# OVERLOOKED MECHANISMS BEHIND SEISMIC DAMAGE

**Photographs of aboveground and underground structural failures after earthquakes uncover simple but not widely recognized physics.**

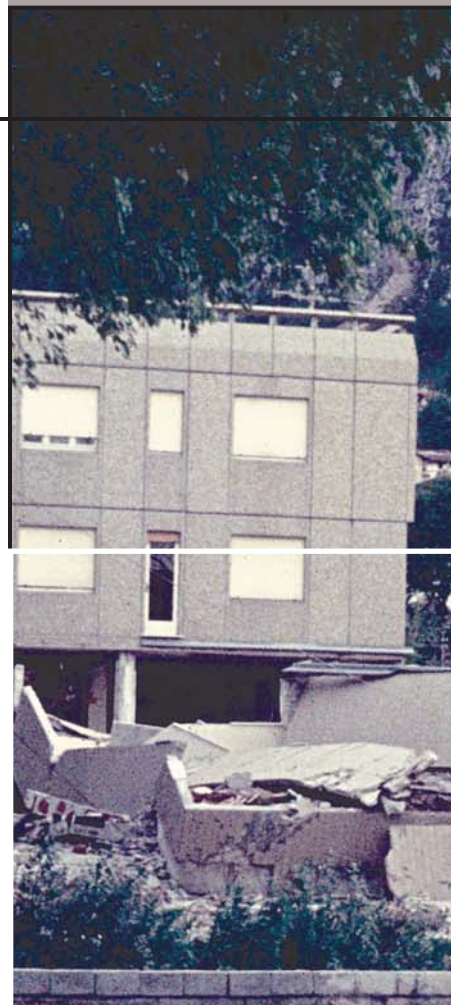
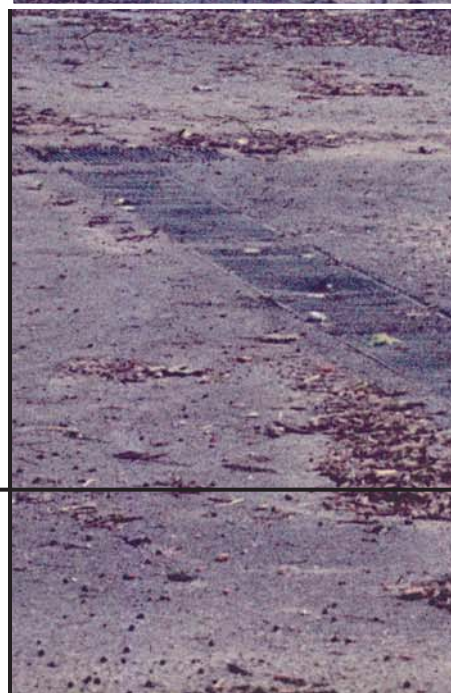
The photograph in figure 1b was taken near Kobe's Rokkomichi railway station and shows archetypal seismic disaster: Wooden houses were completely destroyed, whereas those made of reinforced concrete (RC) were left standing, seemingly unharmed. It agrees with an intuitive image of seismic disasters in which similar structures experience comparable amounts of damage.

RC buildings around Kobe. Figure 1c shows another area in the Rokkomichi district. At first sight, the RC building seems structurally undamaged by the quake. However, a careful look at the picture reveals that the second story is compressed and perfectly flattened. Surprisingly, the signboards remained unaffected, and the upper floors shifted vertically with almost no horizontal movement or deformation. Similar structural damage was observed in other RC buildings near the city center.

**FIGURE 1. (a) THE 1995 HYOGO-KEN NANBU EARTHQUAKE** near Kobe, Japan, produced structural failures throughout the area and at the specific locations indicated. (Adapted from topographic map provided by Geospatial Information Authority of Japan and ref. 3.) **(b)** Mechanically similar structures normally suffer similar levels of damage during an earthquake. In this image taken near Rokkomichi railway station, wooden houses have collapsed while reinforced concrete buildings remain standing. (Courtesy of the City of Kobe.) **(c)** Despite being built from reinforced concrete, a nearby building had its second story vertically compressed so that it completely disappeared. High-frequency seismic waves can account for such localized damage. (Courtesy of Shunsuke Sakurai, Kobe University.)

The insights gained from that sort of conventional engineering have been invaluable. However, localized structural failures whose length scales are on the order of meters or tens of meters, like that in figure 1c, can't be straightforwardly explained by low-frequency horizontal vibrations alone. Consider a 1 Hz *S* wave that propagates at 1 km/s. Its wavelength is 1 km. If it strikes a 10-m-diameter underground tunnel from below, the phase difference between the tunnel's floor and ceiling is negligibly small. The tunnel should therefore move like a rigid body, and the wave shouldn't generate localized damage. According to that picture, a tunnel is perfectly earthquake resistant. Although that may be true if the epicenter is far from the structure and low-frequency seismic waves prevail, the situation isn't necessarily the same for structures near epicenters where high-frequency seismic waves can be dominant.

Simple but rigorous elastodynamic analyses confirm that if 100 Hz *P* waves interacted with the tunnel, the compressive vertical stress acting on the concrete lining could become more than three times as large as that in the incident wave, and the vertical acceleration would be doubled at the tunnel's floor.<sup>2</sup> That stress and acceleration can explain why the tunnel's concrete lining failed in compression and why the road surface detached in response to the earthquake. On the other hand, high-frequency *S* waves and conventional low-frequency waves produce much smaller vertical compressive stress on the wall and acceleration at the bottom. Hence, it seems unlikely that they generated the failures in Bantaki. High-frequency *P* waves are also a likely culprit for the flattened second floor in figure 1c and the collapsed Daikai station in figure 3.<sup>3,4</sup>

Vertical shocks were even felt on ferries (identified in figure 1a) and fishing boats that were at sea during the seismic event.<sup>3,5</sup> Vertical disturbances at sea, known as seaquakes, are felt only near earthquake epicenters. Thousands have been reported, but few are listed in reports like Lloyd's List, which tracks maritime incidents. Thus the study of the vertical shocks near epicenters is difficult.<sup>3</sup>

It's hard to imagine the ground under one's feet dynamically deforming on such short length scales. But during the 1995 Kobe event, a surveyor working in a straight, flat section of a railway tunnel 40 m below the Yodo River in Osaka, more than 40 km from the epicenter (figure 1a), reported just that. He saw the tunnel horizontally winding with apparent amplitude of about 1 m and wavelength of 40–50 m, which supports the idea of town-scale dynamic ground deformation.<sup>5</sup>

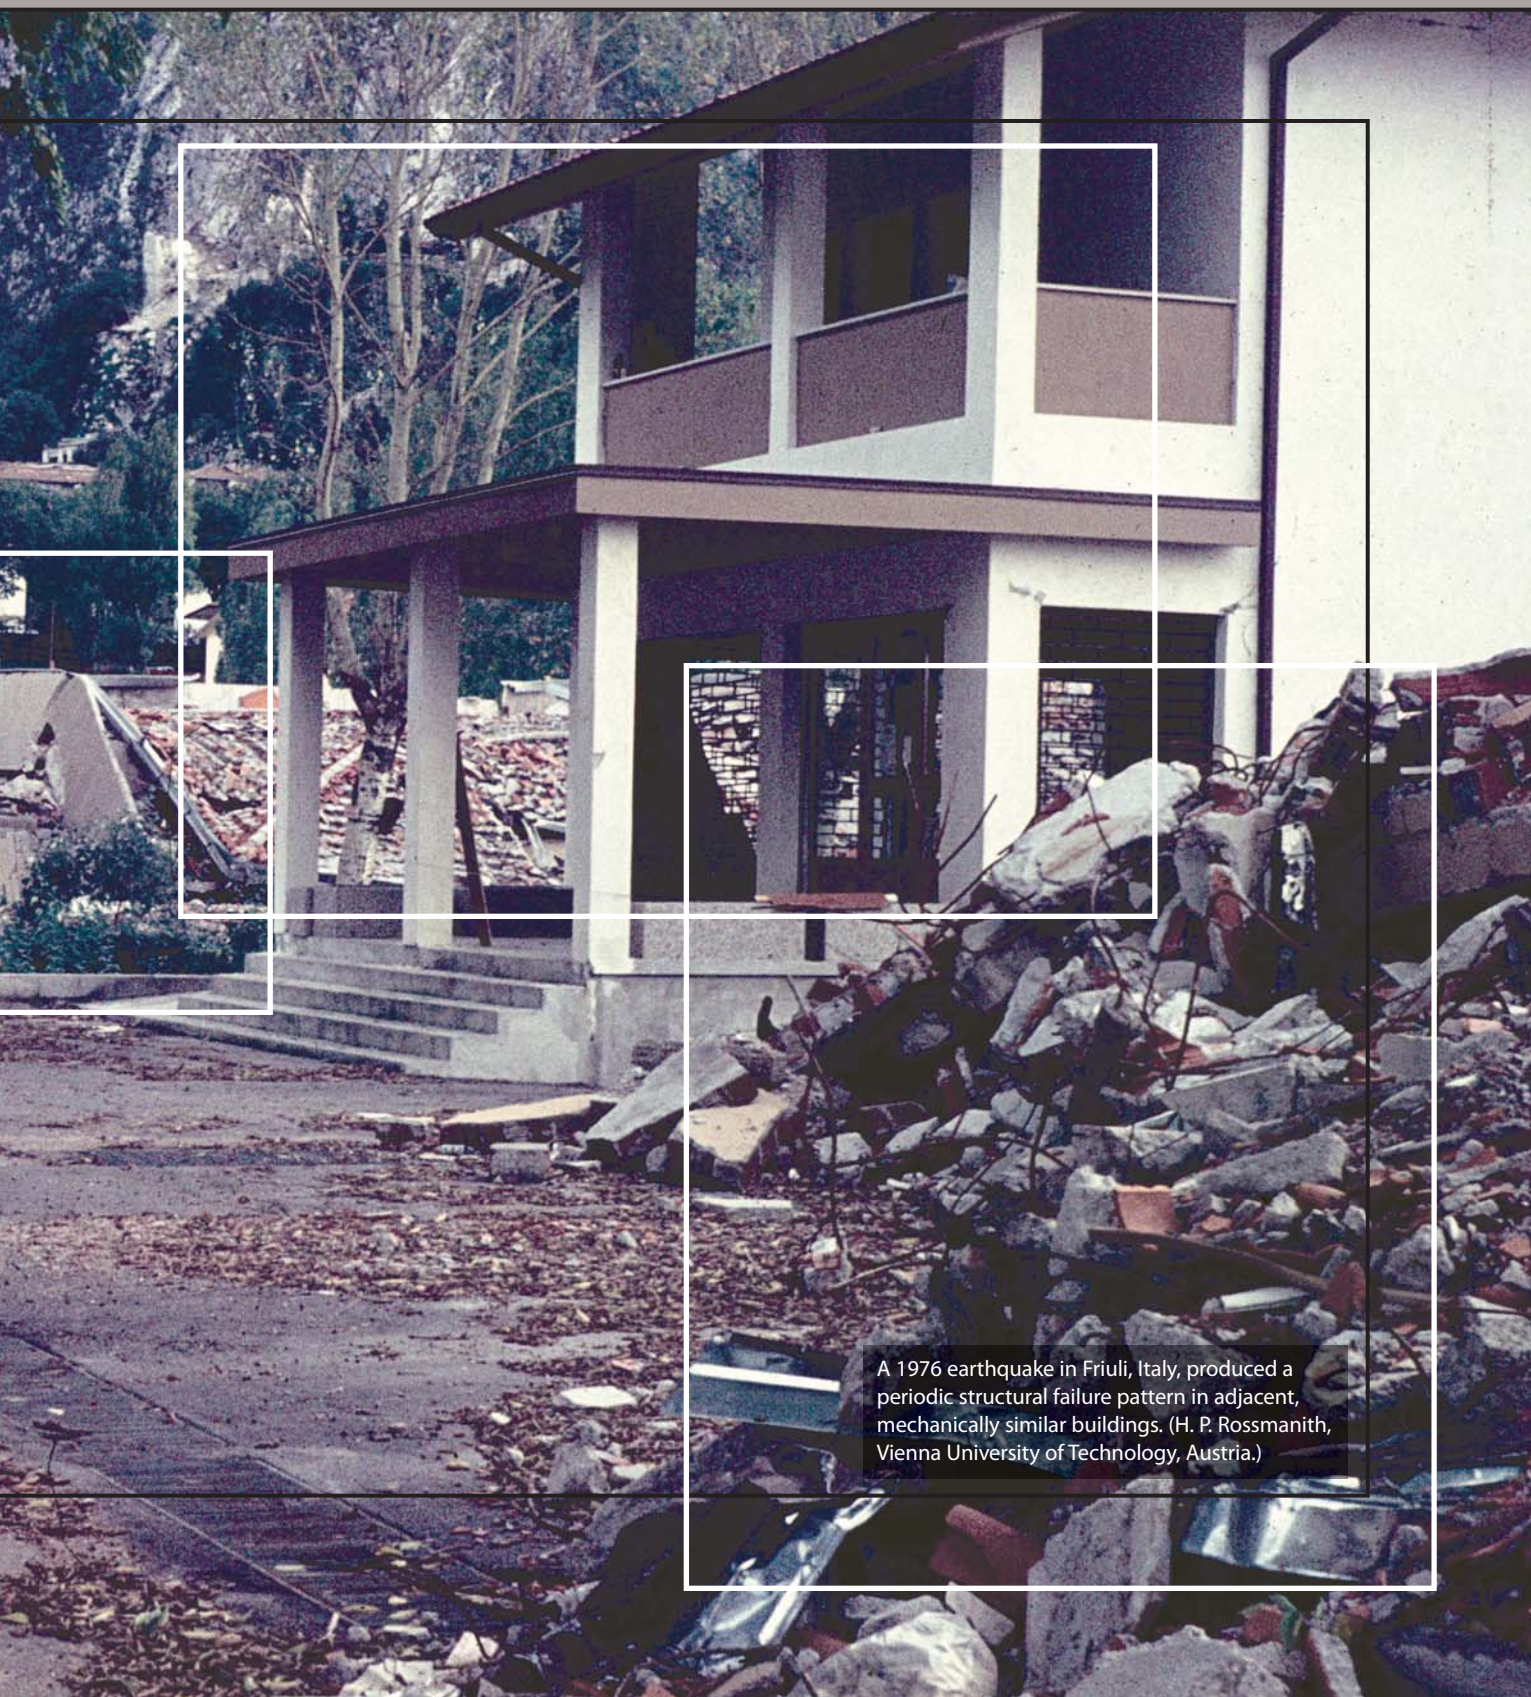
A 1976 earthquake in Friuli, Italy, produced a periodic structural failure pattern in adjacent, mechanically similar buildings. (H. P. Rossmanith, Vienna University of Technology, Austria.)

Nearly half a century ago, an astonishingly periodic structural failure pattern was seen in Italy after the magnitude 6.5 Friuli earthquake (see opening figure). The quake produced an alternating pattern of collapsed and undamaged buildings near the epicenter. In a traditional seismic model, if mechanically and geologically similar buildings are densely packed and subjected to the same seismic waves, they all experience the

Buildings subjected to identical vibration can be endowed with different mechanical characteristics to model the nonuniform levels of damage observed in real earthquakes. But that doesn't explain the regularly alternating damage to similar structures in the opening image. The surprising failure pattern arises naturally, however, if waves with wavelengths on the order of a few buildings are accounted for. Even if only conventional *S* waves with horizontal shaking are assumed, the inclusion of higher-frequency waves and the dynamic interaction between waves and the buildings results in individual buildings in a densely built town experiencing totally dissimilar vibrations.

In a town's fundamental vibrational mode, illustrated in the center panel of figure 6, the buildings at the center of the town vibrate the most whereas those at the edges experience no translational motion. In a higher mode, depicted in the lower panel, every other building may vibrate strongly while the others remain at rest. That disparity in the mechanical behavior of each building is called the town or city effect.<sup>7</sup> In Friuli, where the speed of an S wave through the soft soil is about 225 m/s, generating damage by that mechanism would require a wave with a frequency of about 4 Hz and a wavelength of about 60 m. Those parameters are consistent with the dominant frequencies recorded at the nearby Tolmezzo-Ambiesta dam during the Friuli 1976–77 earthquake sequence. The magnitude 6.2 Dinar earthquake in Turkey in October 1995 produced a similar periodic failure pattern.

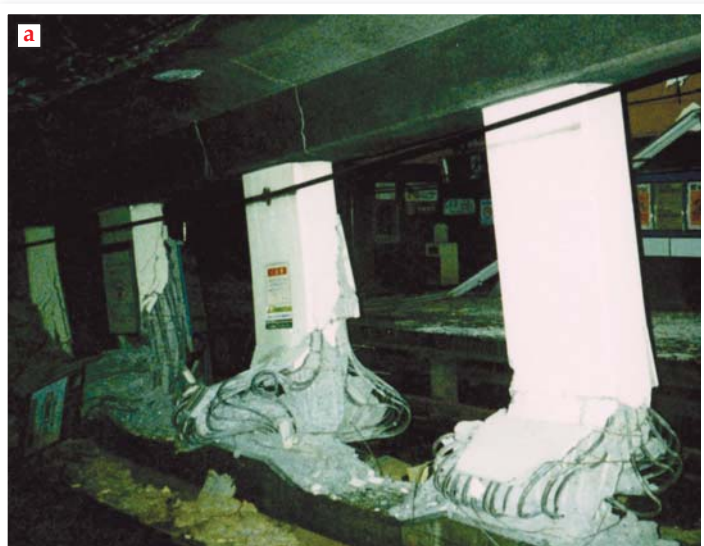
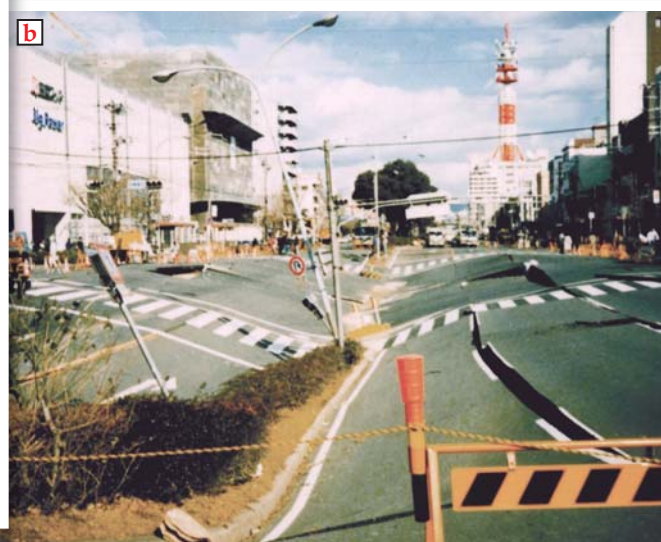
Underground structures are generally believed to be sufficiently strong against earthquakes. And usually they are. But in 1995, the Daikai railway station in downtown Kobe catastrophically failed. At the station, about 5 m below ground, vertical collapse of the reinforced concrete columns supporting the roof (figure 3a) resulted in the failure of the roof and the sinking of the street above (figure 3b).

**FIGURE 3. THE UNDERGROUND DAIKAI STATION** in Kobe, Japan, collapsed during a 1995 earthquake. **(a)** The reinforced concrete columns supporting the roof gave way and **(b)** the street above the station sank in a 100 m × 20 m area; in some places, it fell as much as 2.5 m. The failure disproves the myth that underground structures are safe against earthquakes. (Photographs courtesy of Shunsuke Sakurai, Kobe University.)

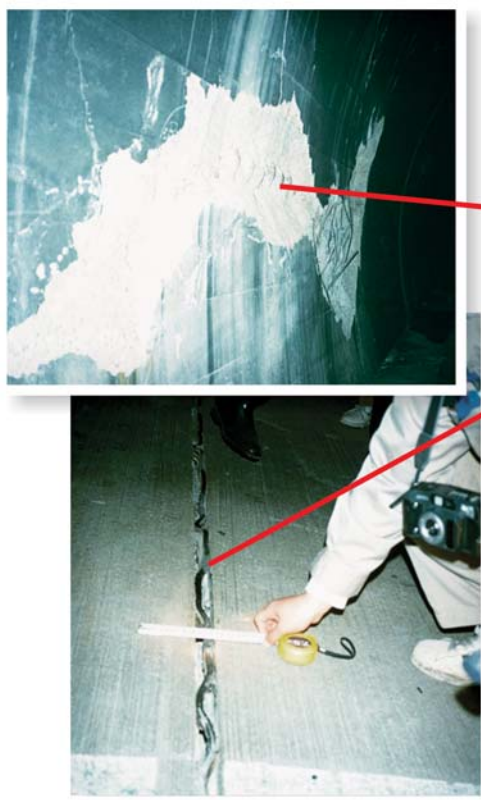
tured from compressive force, and the road surface jumped up from the underlying concrete, known as the invert (see figure 4). Strangely, however, the ceiling, the invert, and the surrounding ground sustained no damage. The geological faults crossing the tunnel hadn't moved.

To understand the mechanism behind the Bantaki failure, consider a *P* wave causing vertical shaking and an *S* wave causing horizontal vibrations, both propagating up toward the tunnel (figure 4). If the *P* wave has a wavelength twice the height of the tunnel—20 m for the approximately 10-m-high Bantaki tunnel—the wave has opposite phases at the tunnel's floor and ceiling. In that case, the wave can leave the top and bottom of the tube intact while generating a large compressive stress in its midsection that destroys the concrete and bends the steel bars reinforcing the wall (figure 4). If the *P* wave's speed is

**FIGURE 4. THE BANTAKI TUNNEL** experienced unfamiliar structural damage during the Hyogo-ken Nanbu earthquake. A high-frequency *P* wave impinging on the tunnel could have caused vertical shaking that dynamically compressed the tunnel and caused the failure observed in Bantaki—namely, the fracture of the concrete wall and the detachment of the road from the tunnel's underlying concrete. An *S* wave with horizontal vibration could not have produced the necessary compressive force in the tunnel's wall. (Photographs courtesy of Shunsuke Sakurai, Kobe University.)

2 km/s in the already-fractured surrounding rock, then the frequency of the incident wave would be 100 Hz, which is well into the high-frequency range.
