# BACK SCATTER

## Fanning flames

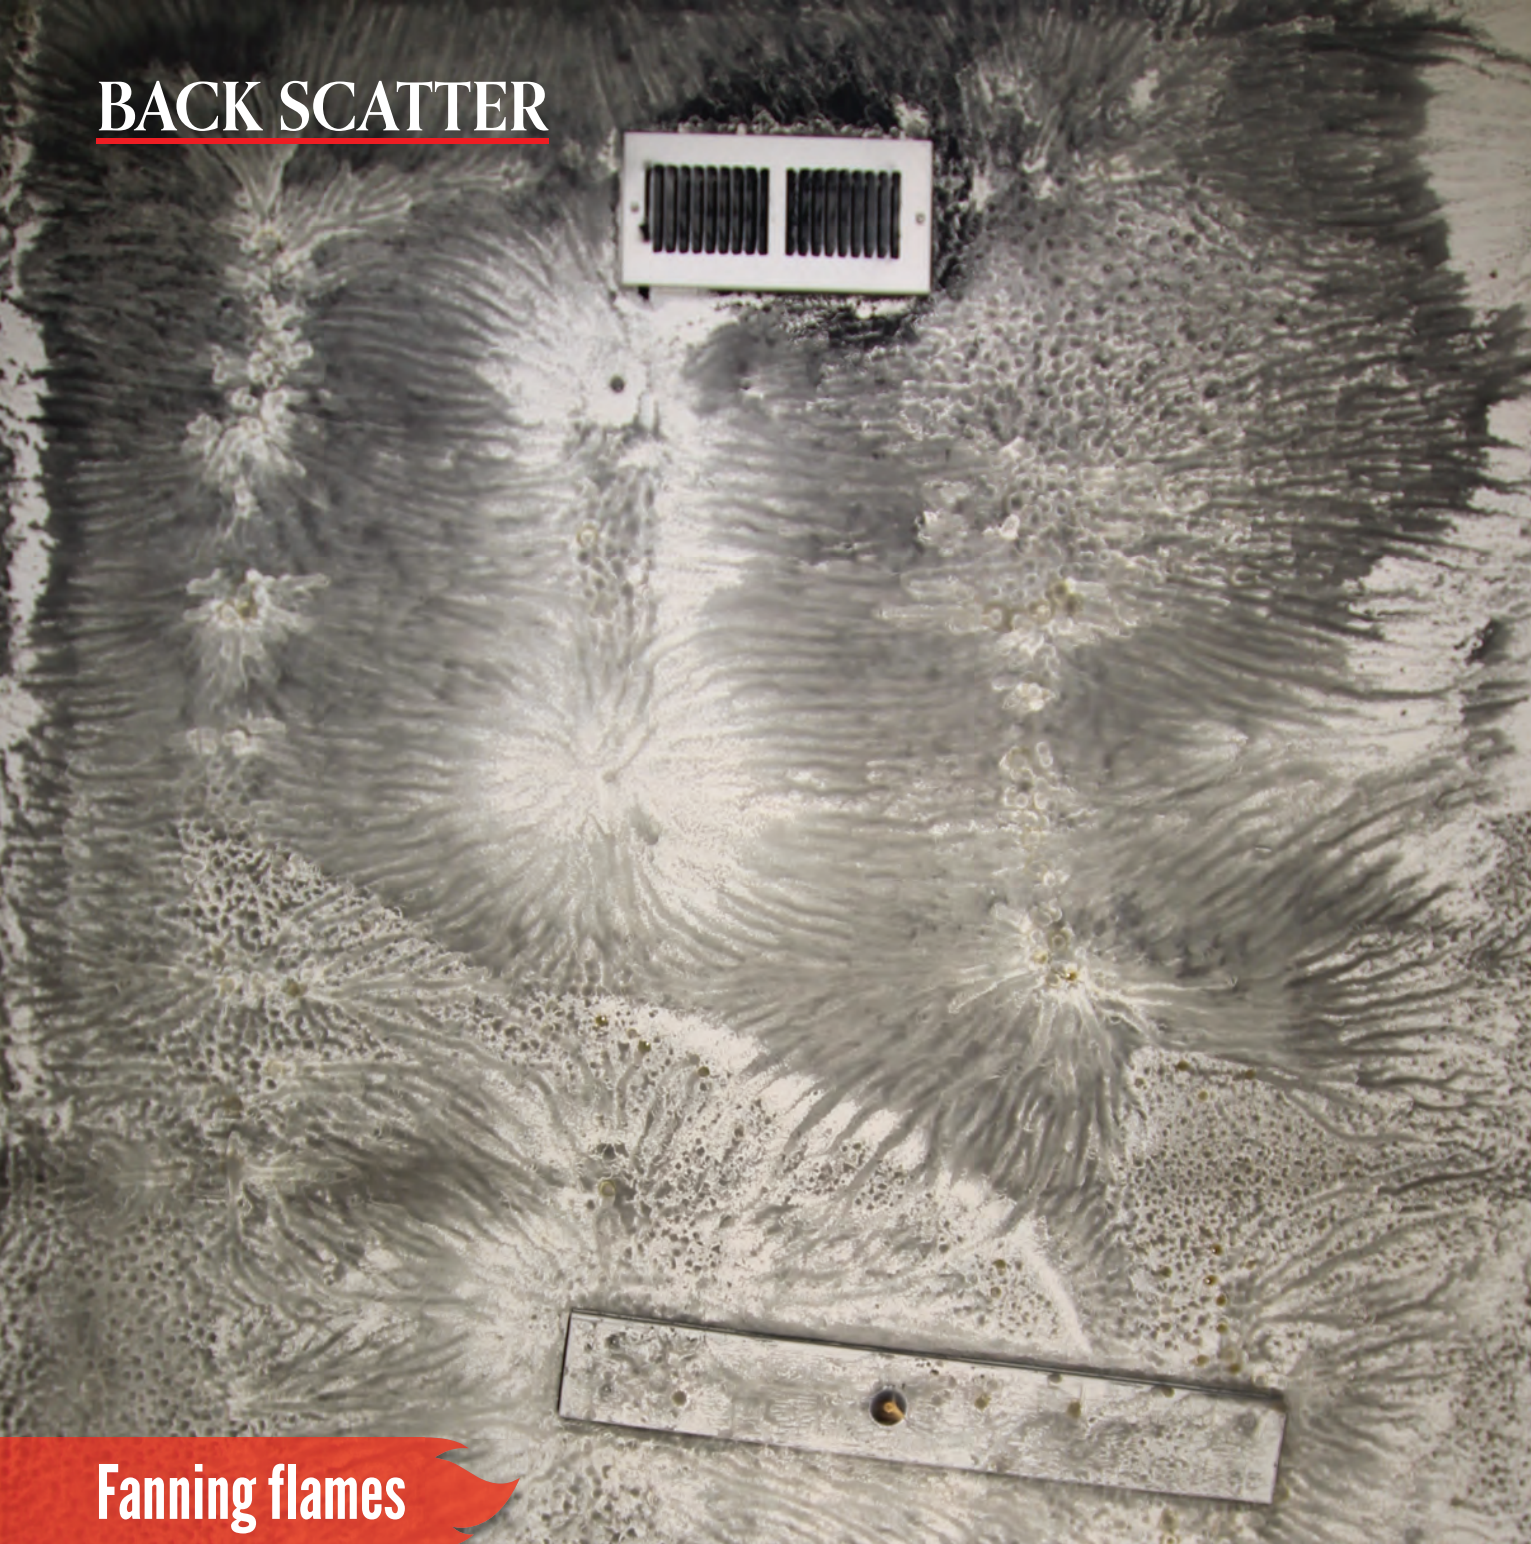
This photo shows the ceiling of a 2.4-meter-wide bathroom in a four-bedroom house a few hours after research engineer Matt DiDomizio and his team at the Underwriters Laboratories' Fire Safety Research Institute started a fire in the house's living room, about 10 meters away from the bathroom. The blaze rapidly grew and developed to such an intensity that the heated air, which was unable to easily pass through the nearby closed bathroom door, entered the HVAC system, which was off during the test.

The sooty air that rushed through the bathroom's ceiling vent plunged toward the floor before rising back up. The hot air deposited solid soot particles on the ceiling in a pattern of lighter and darker bands. The dark circular spots are from soot collecting in water vapor that condensed on the ceiling. The light-dark pattern stems from unstable convection, in which a colder fluid—here, air cooled by the ceiling—is partly blocked from descending by hotter fluid below. (Courtesy of Steven Marino.) —AL
